**Flood Control Project Maintenance**  
**2019 Structure Summary Report**  
**Overall Unit and Item Ratings**

**Turlock Irrigation District Gomes Lake**

**Flood Control Project Maintenance****Unit Cover Sheet****2019 Pumping Plant Inspection Results****Turlock Irrigation District Gomes Lake**

**Levee Inspection Report By Mile - Structure 2019**

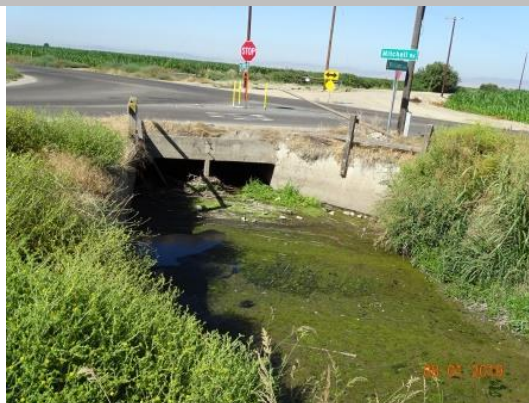
Photo 1 of 4 : ST\_2019\_NA0065\_70\_1\_20190808\_00023.jpg

LM Start	0.00	Rating **	N	Issue No.	1
LM End	0.00	Issue Type +	Ma	Location *	
Category	Structures & Concrete Lined Channels			GPS Latitude/Longitude	
				Start	End
Item	Photo Documentation			37.390522 °	37.390522 °
				-120.941096 °	-120.941096 °
DWR ID	DWR_NA0065_70_t_2017_1				
Action/Comments					
Inspector Comments: This structure is designed to siphon flow diagonally at Mitchell Road and Williams Avenue intersection. Whenever the San Joaquin River stage is such that pumping is necessary at the lower end of Lateral No. 6, the control gates at Mitchell Road shall be closed and all flows of Laterals No 6 and 7 originating above Mitchell Road shall be diverted around the end of the project levee..

View of inlet of siphon structure at corner of Mitchell Rd and Williams Ave. (2019)

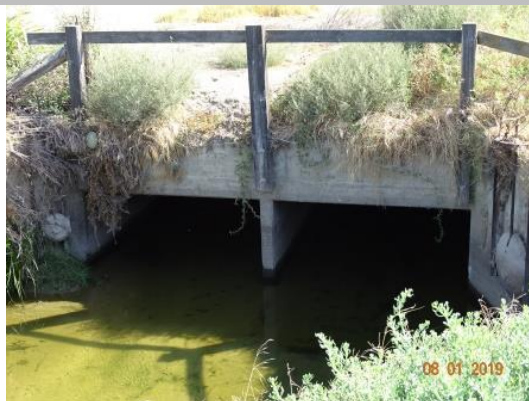
Photo 2 of 4 : ST\_2019\_NA0065\_70\_1\_20190808\_00024.jpg

View of the outlet of the structure looking from Mitchell Road. (2019)

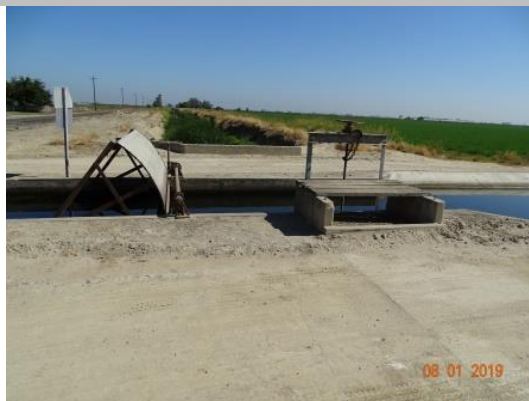
Photo 3 of 4 : ST\_2019\_NA0065\_70\_1\_20190808\_00025.jpg

View of the lateral 7 control gate upstream of the siphon structure. (37.394123, -120.940805) (2019)

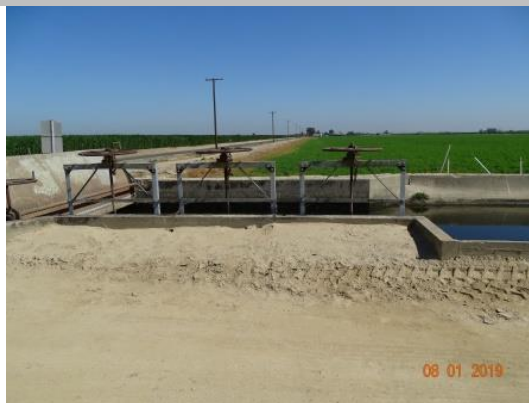
Photo 4 of 4 : ST\_2019\_NA0065\_70\_1\_20190808\_00026.jpg

LM Start	0.00	Rating **	N	Issue No.	1 (cont)	
LM End	0.00	Issue Type +	Ma	Location *		
Category	Structures & Concrete Lined Channels			GPS Latitude/Longitude		
				Start	End	
Item	Photo Documentation			37.390522 °	37.390522 °	
				-120.941096 °	-120.941096 °	
DWR ID	DWR_NA0065_70_t_2017_1					
Action/Comments						
Inspector Comments: This structure is designed to siphon flow diagonally at Mitchell Road and Williams Avenue intersection. Whenever the San Joaquin River stage is such that pumping is necessary at the lower end of Lateral No. 6, the control gates at Mitchell Road shall be closed and all flows of Laterals No 6 and 7 originating above Mitchell Road shall be diverted around the end of the project

View of the lateral 6 control gates upstream of the siphon structure. (37.406061, -120.940602) (2019)

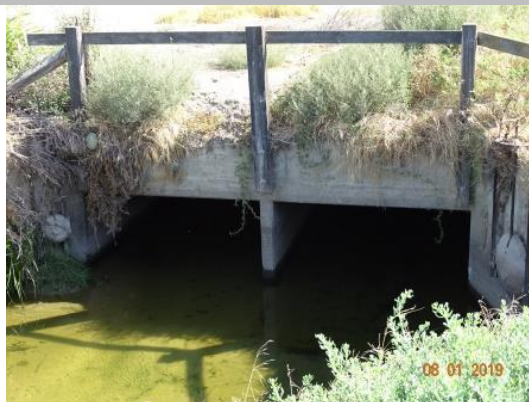
Photo 2 of 4 : ST\_2019\_NA0065\_70\_7\_20190808\_00030.jpg

View of the outlet culvert at the siphon structure. (2018)

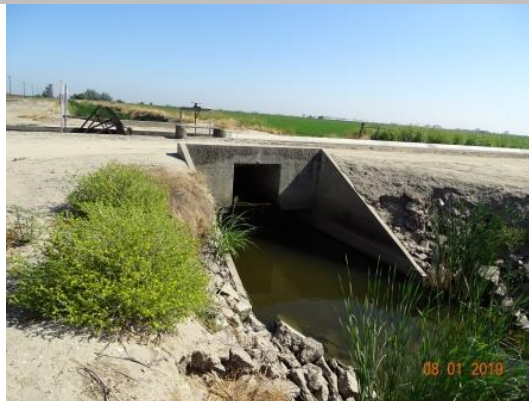
Photo 3 of 4 : ST\_2019\_NA0065\_70\_7\_20190808\_00033.jpg

LM Start	0.00	Rating **	A	Issue No.	7 (cont)	
LM End	0.00	Issue Type +	Ma	Location *		
Category	Structures & Concrete Lined Channels			GPS Latitude/Longitude		
				Start		End
Item	Culverts: Inlets / Outlets			37.390522 °		37.390522 °
				-120.941096 °		-120.941096 °
DWR ID	DWR_NA0065_70_t_2017_7					
Action/Comments						
Inspector Comments: Inlet and outlet culvert were working fine without significant blockage during the inspection.

View of the outlet culvert at the lateral 7 gate. (37.394123, -120.940805) (2017)

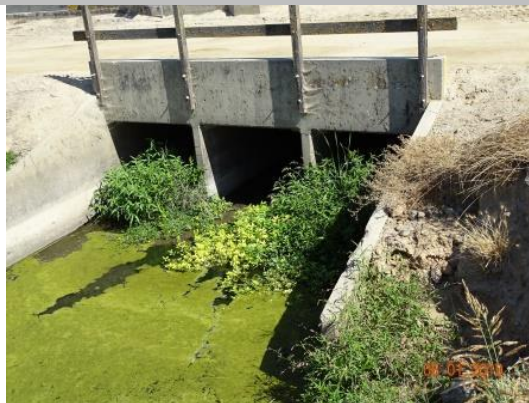
Photo 4 of 4 : ST\_2019\_NA0065\_70\_7\_20190808\_00033.jpg

View of the outlet culvert at the lateral 6 gates. (37.406061, -120.940602) (2017)

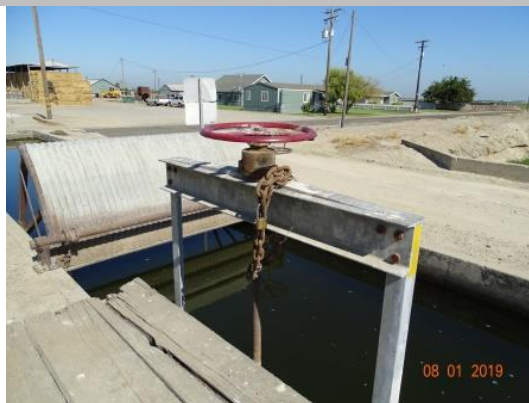
Photo 1 of 5 : ST\_2019\_NA0065\_70\_12\_20190808\_00034.jpg

LM Start	0.00	Rating **	A	Issue No.	12
LM End	0.00	Issue Type +	Ma	Location *	
Category	Structures & Concrete Lined Channels			GPS Latitude/Longitude	
				Start	End
Item	Sluice/Slide Gates			37.390522 °	37.390522 °
				-120.941096 °	-120.941096 °
DWR ID	DWR_NA0065_70_t_2017_12				
Action/Comments					
Inspector Comments: Lateral 6 (37.406061,-120.940602) and lateral 7 (37.394123,-120.940805) control gates divert the water through the siphon structure during flood flow stage. The gasket on the radial gate at lateral 6 has deteriorated and should be replaced.

View of the slide gate at lateral 7. (37.394123, -120.940805) (2018)

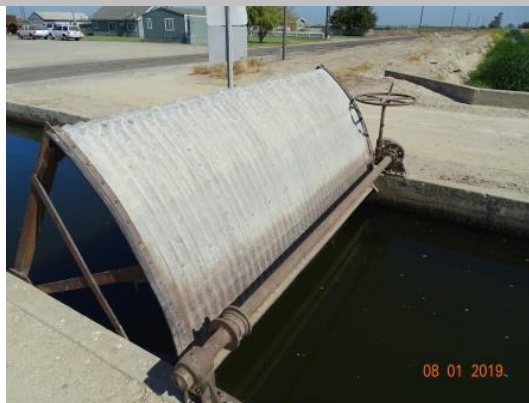
Photo 2 of 5 : ST\_2019\_NA0065\_70\_12\_20190808\_00035.jpg

View of the radial gate at lateral 7. (37.394123, -120.940805) (2018)

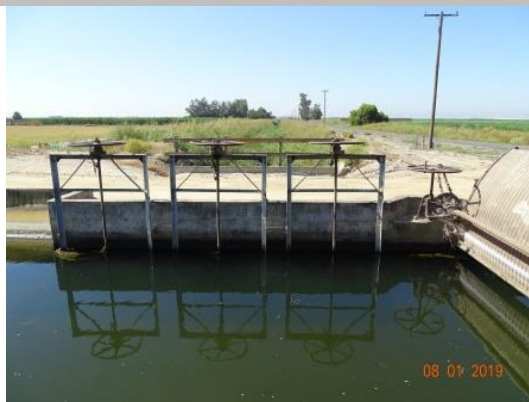
Photo 3 of 5 : ST\_2019\_NA0065\_70\_12\_20190808\_00037.jpg

View of the slide gates at lateral 6. (37.406061, -120.940602)

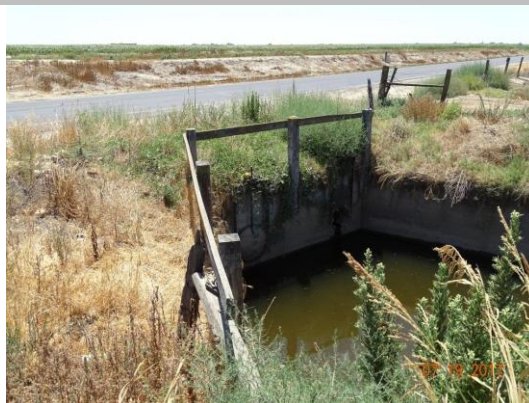
Photo 2 of 3 : ST\_2019\_NA0065\_70\_23\_20190613\_00020.jpg

View of the wooden rails at the outlet of the structure. (2017)

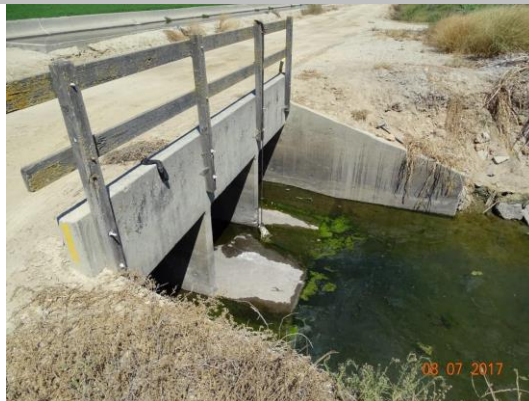
Photo 3 of 3 : ST\_2019\_NA0065\_70\_23\_20190613\_00022.jpg

LM Start	0.00	Rating **	M	Issue No.	23 (cont)
LM End	0.00	Issue Type +	Ma	Location *	
Category	Structures & Concrete Lined Channels	GPS Latitude/Longitude			
		Start		End	
Item	Safety	37.390522 °		37.390522 °	
		-120.941096 °		-120.941096 °	
DWR ID	DWR_NA0065_70_t_2017_23				
Action/Comments					
Inspector Comments: Safety railings at the inlet side of the siphon structure have fallen off the posts and should be fixed.

View of the wooden rails at the lateral 6 outlet structure. (37.406061, -120.940602) (2017)
